WESTON HERITAGE CONSERVATION DISTRICT PLAN
Phase One
Town of Weston

1.0 INTRODUCTION

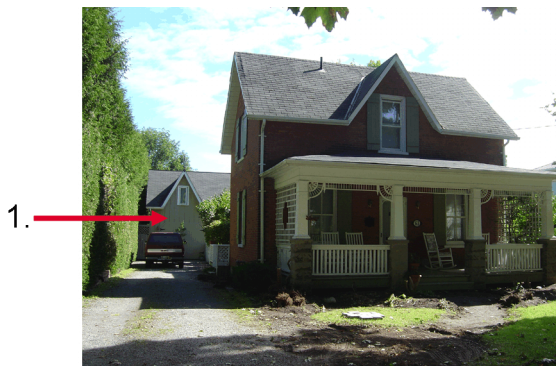
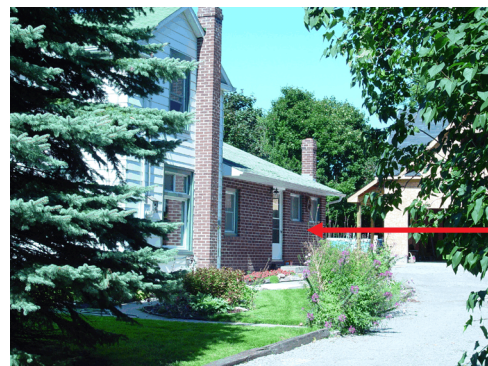
1. Greenhouses, garages, exterior additions and balcony design location to be situated at the rear of original building or on a non predominant side.

They should not compete with original building in scale and/or size, but should compliment the existing form and adjacent buildings.
2. Keep the roof line lower than the main roof ridge line.
3. The additions should step in at the sides, so that the existing building street facade remains dominant to all other facades.
4. Avoid asymmetrical additions to an existing building with a symmetrical facade.

5. There should be a discernable difference between original built form and new.

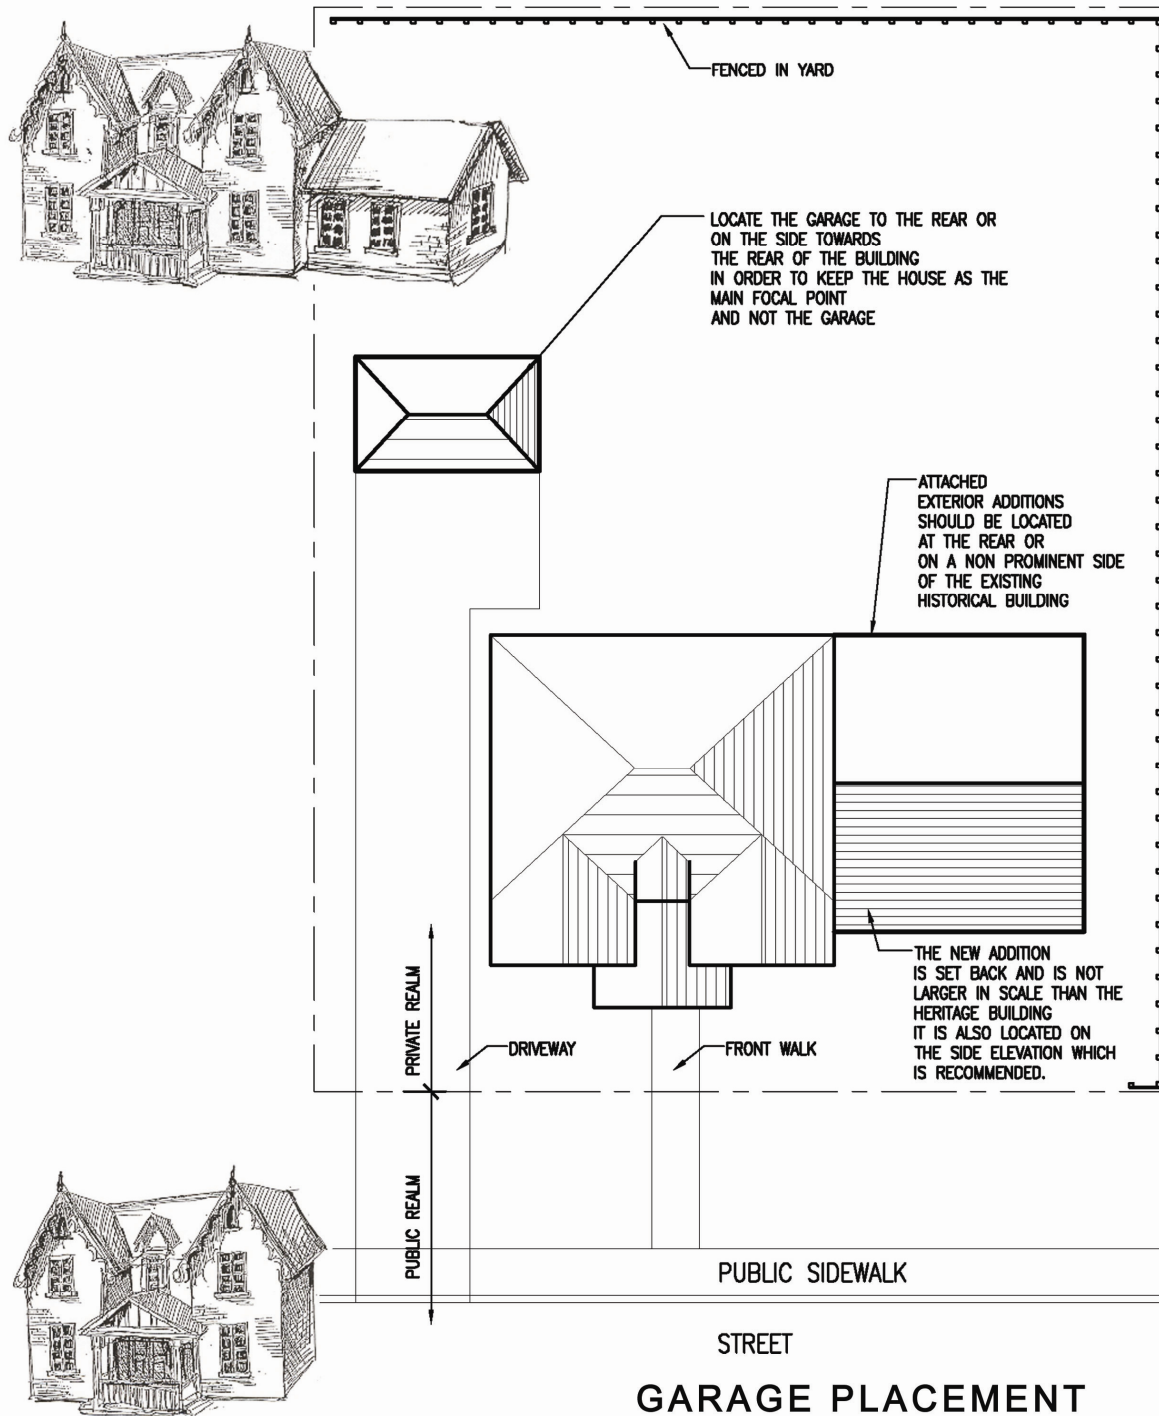
TWO STOREY PITCHED ROOF

GARAGE PLACEMENT EXTERIOR SIDE ADDITION

Refer to the following pages for Plans showing garage and exterior attached additions in the recommended locations.
